TECHNICAL INFORMATION

ICP-CC488P, CC408P, CC404P

PCB Modifications

December 19, 2008

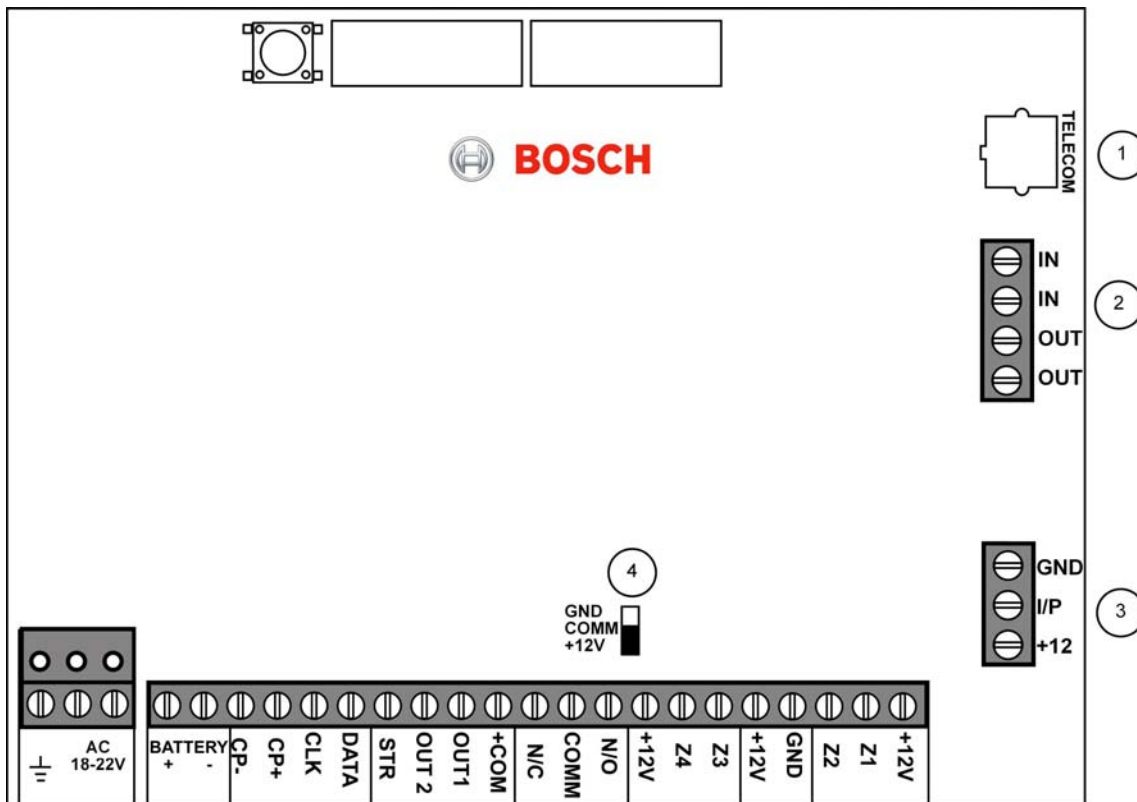
This version of the Solution ICP-CC488P, ICP-CC408P, or ICP-CC404P Control Panel Printed Circuit Board (PCB) is modified when compared to earlier versions. Make sure you pay attention to the modifications when creating your PCB connections. The PCB modifications are described below:

- TELECOM connector (Item 1): This connector is in a new location on the PCB.
- TELECOM terminal block (Item 2): This terminal block is in a new location on the PCB.
- Receiver Interface terminal block (Item 3): This terminal block is in a new location on the PCB, and the terminals are reversed when compared to earlier PCBs. This terminal block is available only on the ICP-CC488P Control Panel PCBs.
- Relay Contact connector (Item 4): This connector is in a new location on the PCB, and the terminals are reversed when compared to earlier PCBs.
